Co₂olBricks

Improving the Energy Efficiency of Historic Buildings

A handbook of best practice examples,
technical solutions and research projects

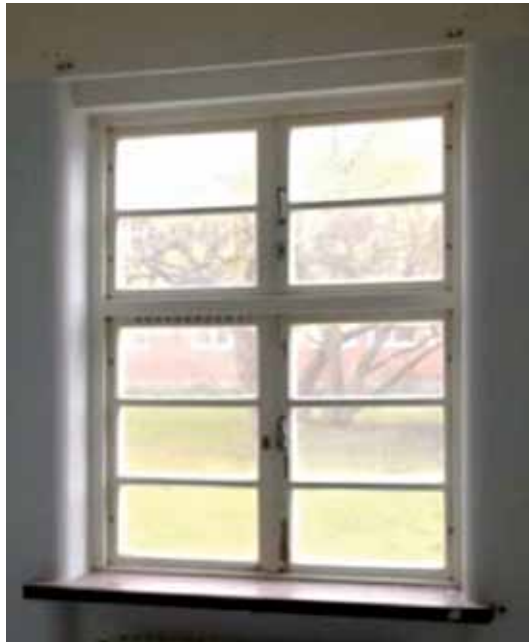
Figure 2: Existing window from the building studied

The share of the energy loss due to windows is quite substantial. However, there is great variation depending on different factors such as the number of windows, their size and U-value. Figure 2 shows a window from the building which was studied. The window is divided into four parts with window bars. Because the window has the highest U-value around the casing frames, these types of windows are not a good solution from an energy-saving viewpoint. Further, the windows are single-glass windows and the estimated U-value is 3.0 W/m²K.

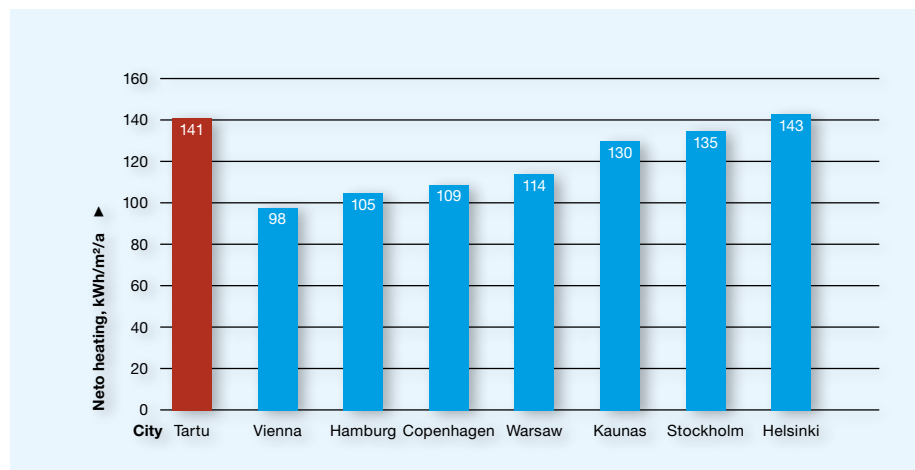
Figure 13: Adapting the weighted average heat consumption of Tartu brick buildings to the climatic conditions of other cities

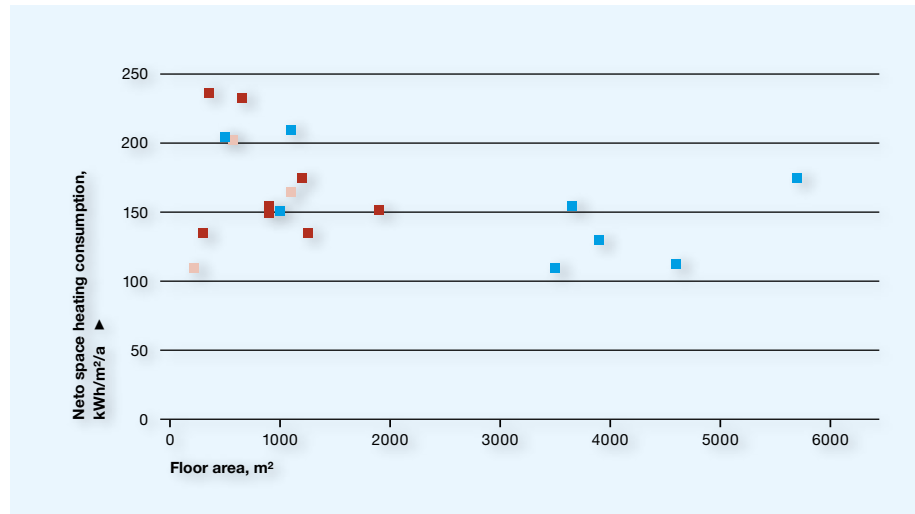
Figure 14: Dependence of the net heat energy consumption on the size of the heated area (blue: schools, red: other buildings, yellow: residential buildings)

The net heat energy consumption of a building in the buildings that participated in the study did not depend considerably on the size of the heated area.

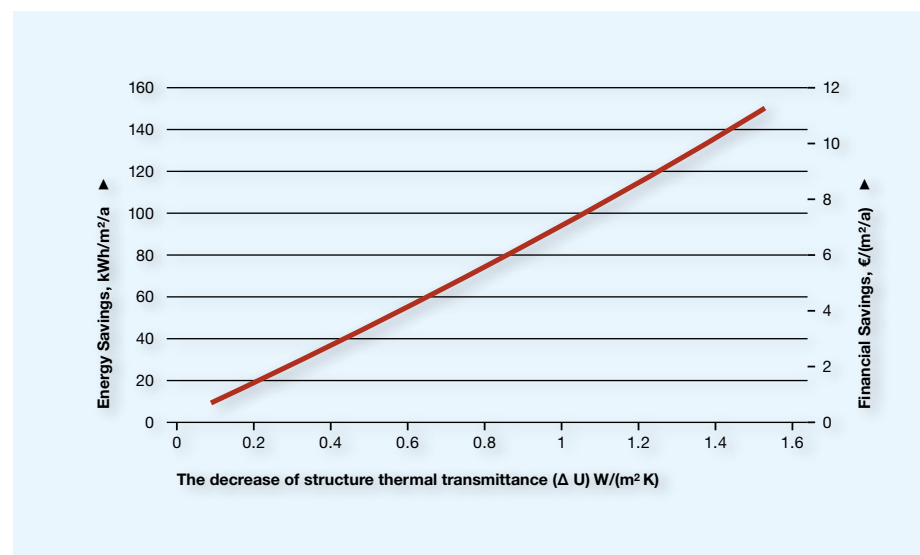
Figure 17: Energy and financial savings based on 1 m² structure area depending on the structure thermal transmittance decrease (Energy cost 70 €/MWh)

An example regarding the roof structure insulation: the roof structure with its prior thermal transmittance of $1.15 \text{ W/m}^2\text{K}$, about 20–25 cm thick thermal insulation layer is required to achieve U-value of $0.15 \text{ W/m}^2\text{K}$, and the decrease of structure thermal transmittance is $\Delta U = 1.15 - 0.15 = 1 \text{ W/m}^2\text{K}$. $\Delta U = 1$ would provide the annual energy savings (Figure 17) of $95 \text{ kWh/m}^2/\text{a}$ ($6.7 \text{ €/m}^2/\text{a}$) for 1 m^2 of roof structure. In case of the 100 m^2 roof, the annual energy savings are equal to $95 * 100 = 9,500 \text{ kWh/a}$ (670 €/a).

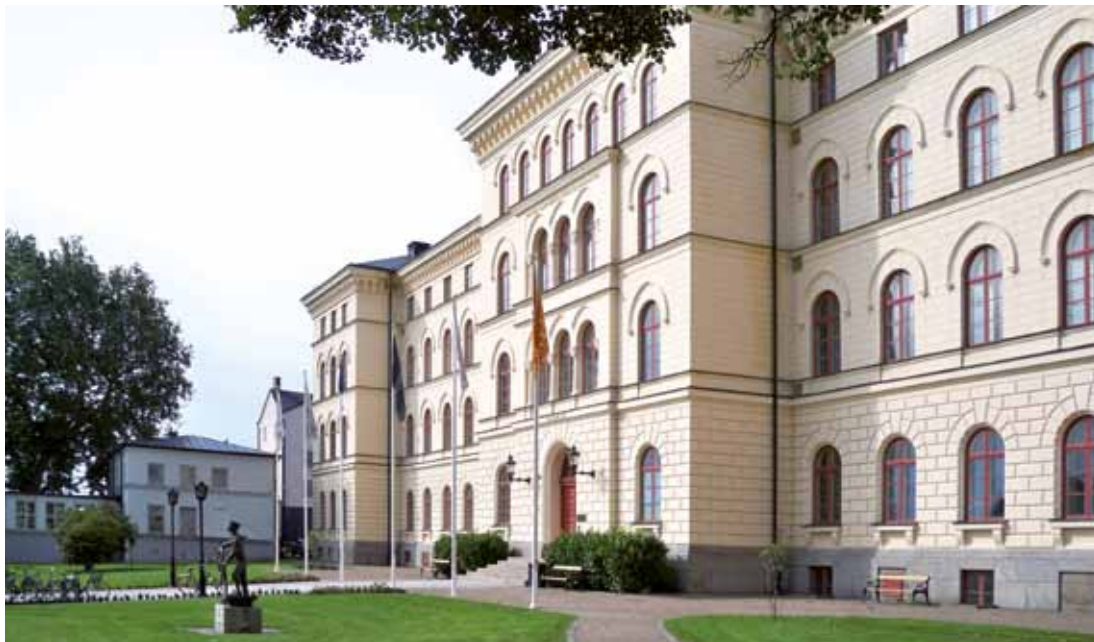
The Skeppsgossen building is characterized by the Neo-Renaissance architecture of the late 1800s and has been protected since 1935 as a national monument. The building became a school for young boys who were trained to be officers or sailors.

Address: Skeppsgossen, Amiralitetstorget 3, KARLSKRONA
Building type: school
Architect: Axel and Hjalmar Kumlien
Year of construction: 1878–1881
Owner: The National Property Board of Sweden
Used as: offices, school
Number of floors: 4
Façade: plastered bricks
Floor space: 5,900 m² + 543 m²
Heated area: as above

The age and the size of the building increased the need for saving energy as well as improving the comfort in order to still use it as offices and for teaching. Due to the high level of heritage protection and the good condition of the building in general, the possible measures were limited. Therefore the following measures were chosen to improve the building for energy efficiency as much as possible at this time.

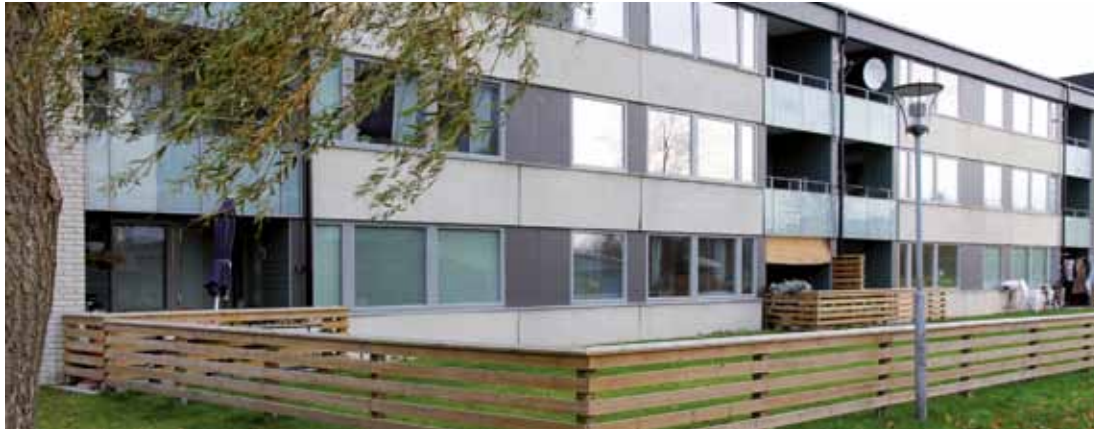
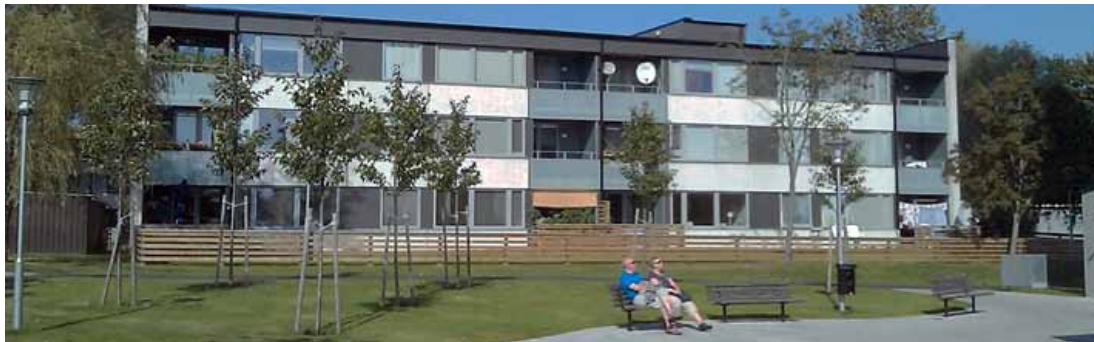
This is a traditional apartment house built in the early 1970s during the Swedish 'million apartment programme' 1965–1975. This specific building has 12 apartments and is the first to be renovated among 16 similar buildings in this area. Planning for this area is ongoing.

Address: Nydalavägen 20, Växjö
Building type: apartments
Architect: unknown
Year of construction: 1971–72
Owner: Växjöhem
Used as: dwellings
Number of floors: 3
Façade: bricks+board
Heated area: appr. 750 m²
Cost of refurbishment: total 9,600,000 SEK
(Energy-measures: 2,400,000 SEK)

Belongs to the 'million apartment programme' 1965–1975. Not protected.

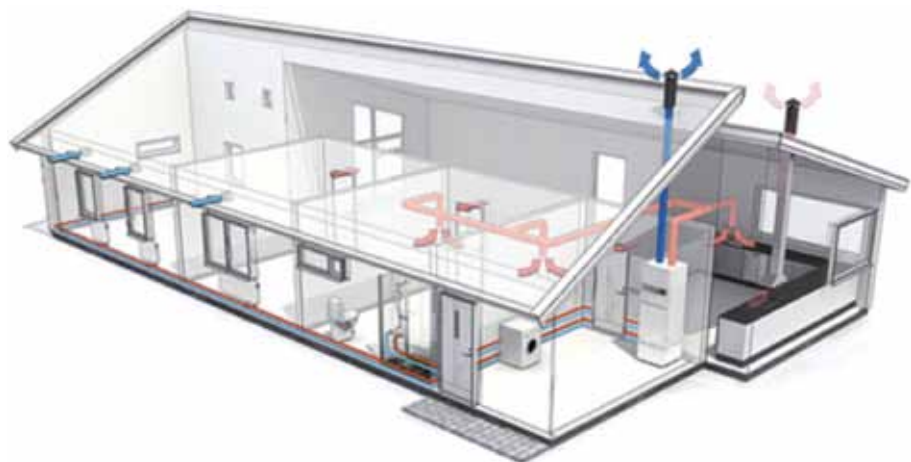
Figure 21: Working principle of exhaust air heat pump.
(Source: www.nibe.com)

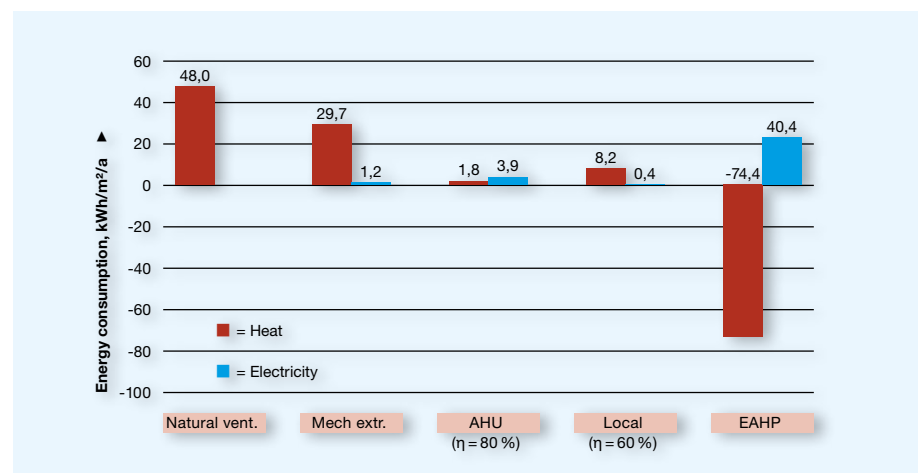
Figure 22: Estimated annual energy consumptions of different ventilation system solutions in a 60m^2 flat. (Natural vent. – Natural ventilation; Mech. extr. – Mechanical extraction system; AHU ($\eta=80\%$) – Central air handling unit system with heat recovery 80%; Local ($\eta=60\%$) – Local decentralised system with heat recovery 60%; EAHP – Exhaust air heat pump)

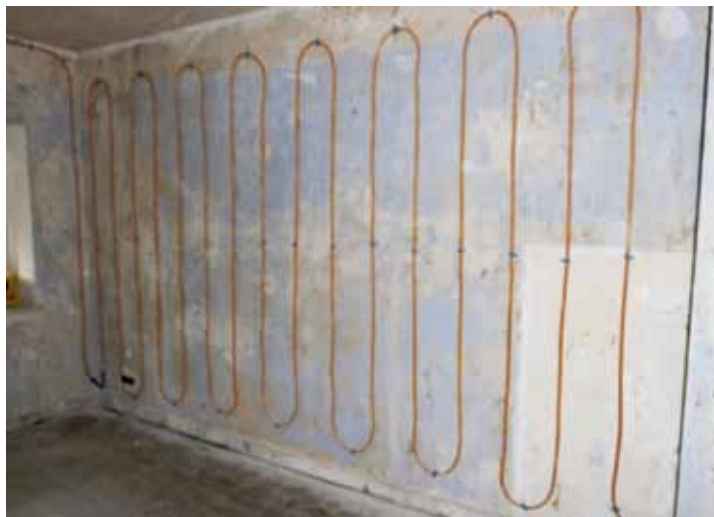
Figure 22: Wall heating system (Source: Heritage Department Hamburg)

In existing buildings, especially with historical value, the installation on the wall is often easier to realise than the installation on the floor. Furthermore, for buildings with moisture problems the increase of the surface temperature additionally dries the wall, and thereby has a small beneficial effect on the U-value. One of the disadvantages is that furniture placed in front of a wall heating system impairs the heating function: another is that drilling into the wall might damage the heating system mechanically.
